A Field Trial of Using High-Density Polyethylene for Internal Lining of Production Tubing in Highly Deviated Wells Produced by Sucker-Rod Pumps

General Petroleum Company, Cairo, Egypt

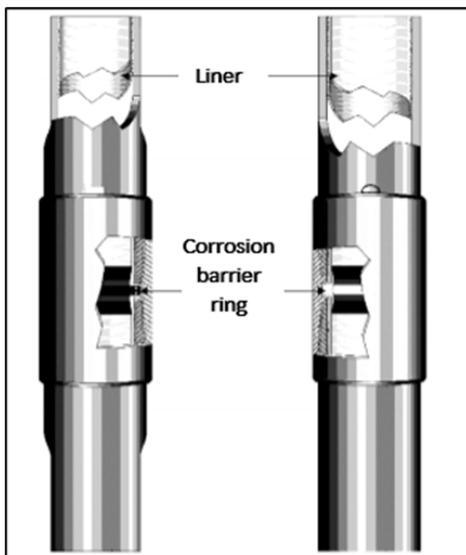
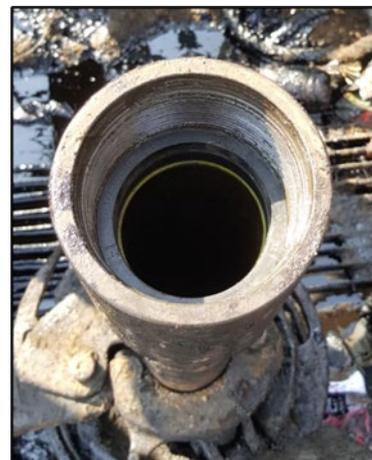
Figure 1. A) An illustrative diagram showing the CBR between two lined-pipe-pin ends [2], B) A Realistic picture of CBR

- 1- The following string was run first before running the lined pipes; perforated joint – unlined tubing joint – seating nipple.
- 2- Between two pin ends inside a coupling, there is a clearance that should be filled with a corrosion barrier ring (CBR) to completely isolate the steel from the attack of corrosive fluids. Figure 1.-A illustrates a schematic diagram for CBR and how it isolates the connection steel from direct contact with corrosive fluids. Figure1.-B represents a realistic picture for CBR.

- 3- CBR has different lengths; 0.25", 0.5" & 0.75". By measuring the remaining length of the coupling's thread and the other pipe's pin thread length, the length of CBR is determined.

It should not be smaller than the clearance to avoid poor isolation and not larger than it to avoid CBR collapse when connecting pipes [4].

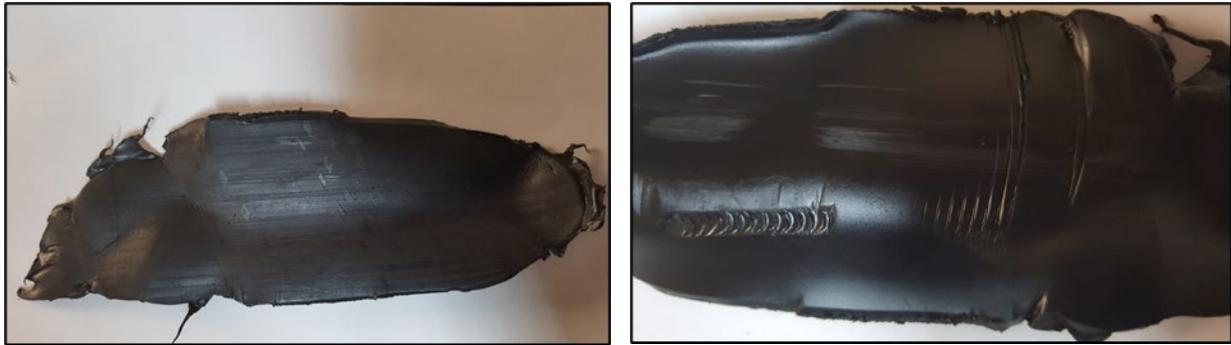
Figure 2. Pictures of a one of the found part that were found stuck in the pump when it is retrieved in Feb-2020

When the pump was retrieved to be changed/repared in Feb-2020, some lining part was found stuck in the pump; Figure 2. By analyzing this part, it was assumed that this part was cut from a deep joint beside the seating nipple and failure occurred due to multiple attempts to set the pump in its nipple. According to trial conditions, it was decided to continue the trial till a major failure in the lined tubing that needed to be pulled out. The pump was retrieved again three times till July-2020, and in each time, there was a part stuck to the pump.

In July-2020, the pump was retrieved with larger overpulls compared to previous retrievals to be changed by a new one. When it was run in the well, it was not be able to be seated in its seating nipple because of an obstruction resulting in the necessity to pull out the lined tubing. When the lined tubing string was retrieved, it is found that seven lined joints were severely damaged, and the cuts were accumulated on the seating nipple forming the obstruction. The damaged joints are 23, 30, 35, 59, 60, 64 & 66.

Obviously, the upper three joints with depths of 620, 810 & 945 feet were damaged because of high tubing/rod string wear resulting from the dogleg angle, as illustrated in Appendix B. The lower four joints were most probably damaged because of attempts to set the pump in its seating nipple. The possible analysis of the difficulty to retrieve the pump was either because of the accumulation of lining cuts above the pump, or barely because of swelling in HDPE lining. It is decided to stop the lining trial in this well because it fails to fulfil its conditions.

The trial of internal HDPE lining to be used in downhole tubing was the first in GPC and in Egypt. It cannot be judged that it is fruitful by its success in one well. It should be examined in more wells. The possible causes of the trial failure in GH-237 should be re-evaluated and discussed; such as bad blending or bad blend injection, lining swelling because of gas presence, bad handling, sensitivity to critical temperatures, or other causes. For further precautions, an oil sample from each well should be sent to evaluate the compatibility test and the effect of this sample on HDPE behavior.
