ESTABLISHING THE REASONS AND TYPE OF THE ENHANCED CORROSION IN THE CRUDE OIL ATMOSPHERIC DISTILLATION UNIT

The aim of the present study is to establish the reasons for a real accident observed in the installation for atmospheric distillation of petroleum of LUKoil Neftochim Bourgas Co. and taking precaution measures to prevent such accidents in future.

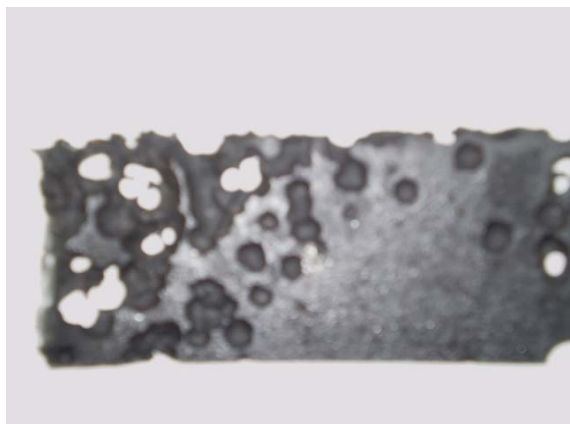
The metal sample shown in Fig.2 is part of a beam mounted at the inlet of the rectification column, subjected to temperatures up to 360°C. The sample surface is covered with spots and pits of oval shape, with perforations at some places. The average beam

thickness was measured to be 4.6 mm, compared to the initial thickness of 6.0 mm. All surfaces were covered with fine black sulfide layer [4].

Fig. 2 A part of plate on the tray section

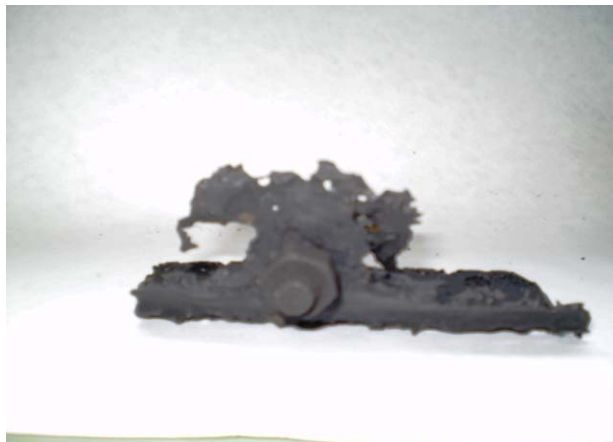
Fig. 3 Binding elements – plates, bolts and nuts on the tray section

Figure 3 shows the binding elements to the same beam, made of high alloyed kinds of steel. The photograph clearly shows that the corrosion affected only the beam [9].
